## Appendix E Photographs

**Figure 1:** Site Layout Map of the Buisplaas Waste Disposal Facility on a portion of the Remainder of Portion 1 of the Farm Buffelsdrift No. 191, Mossel Bay Registration Division, indicated by the red polygon (Source: CapeFarmMapper [CFM], 2023). The blue polygon indicates the position of the excavated waste body. The numbers given on the map indicate the position at which the photos of this photo sheet were taken on the application site (in order).

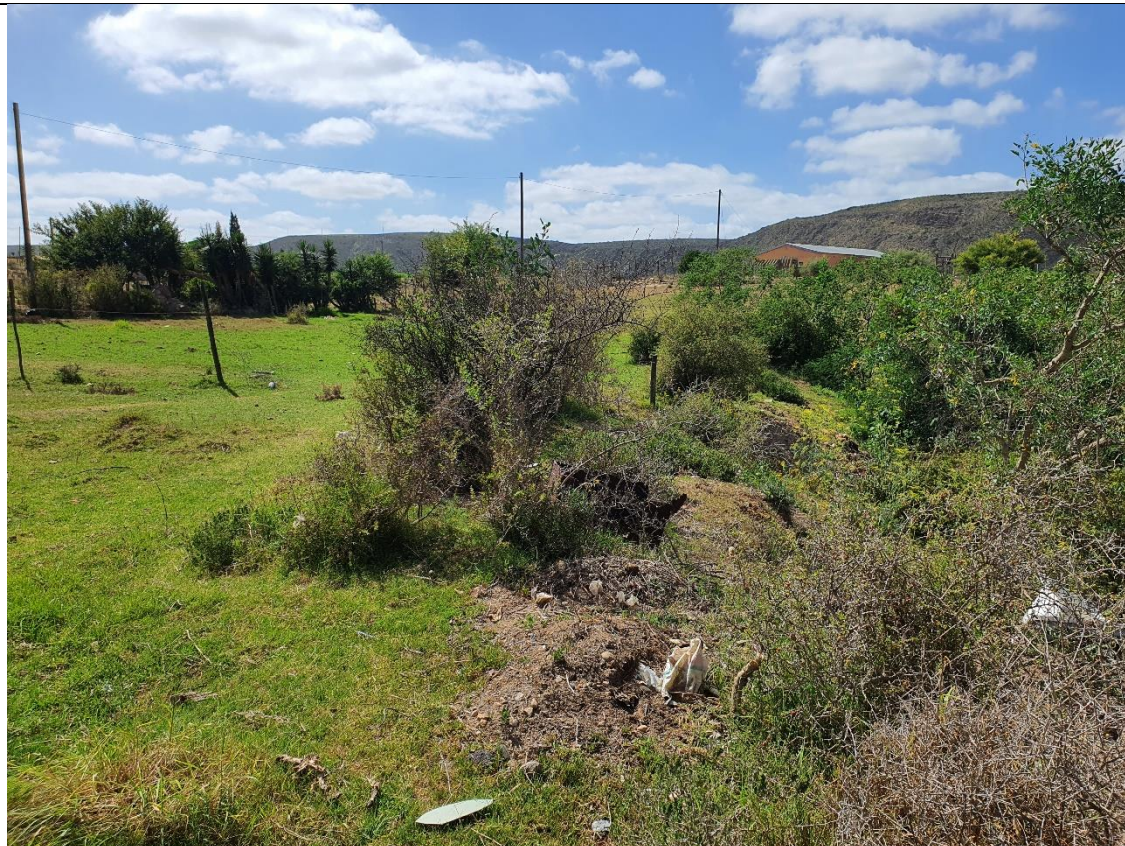
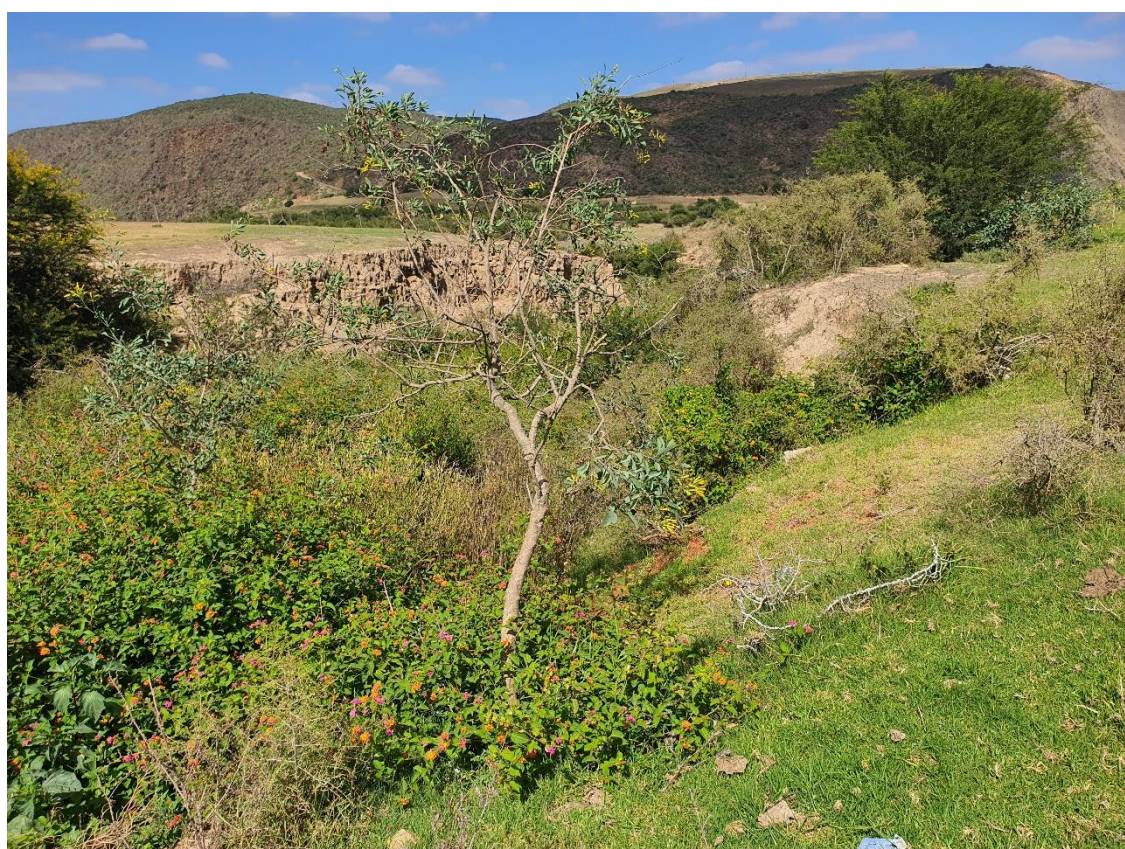
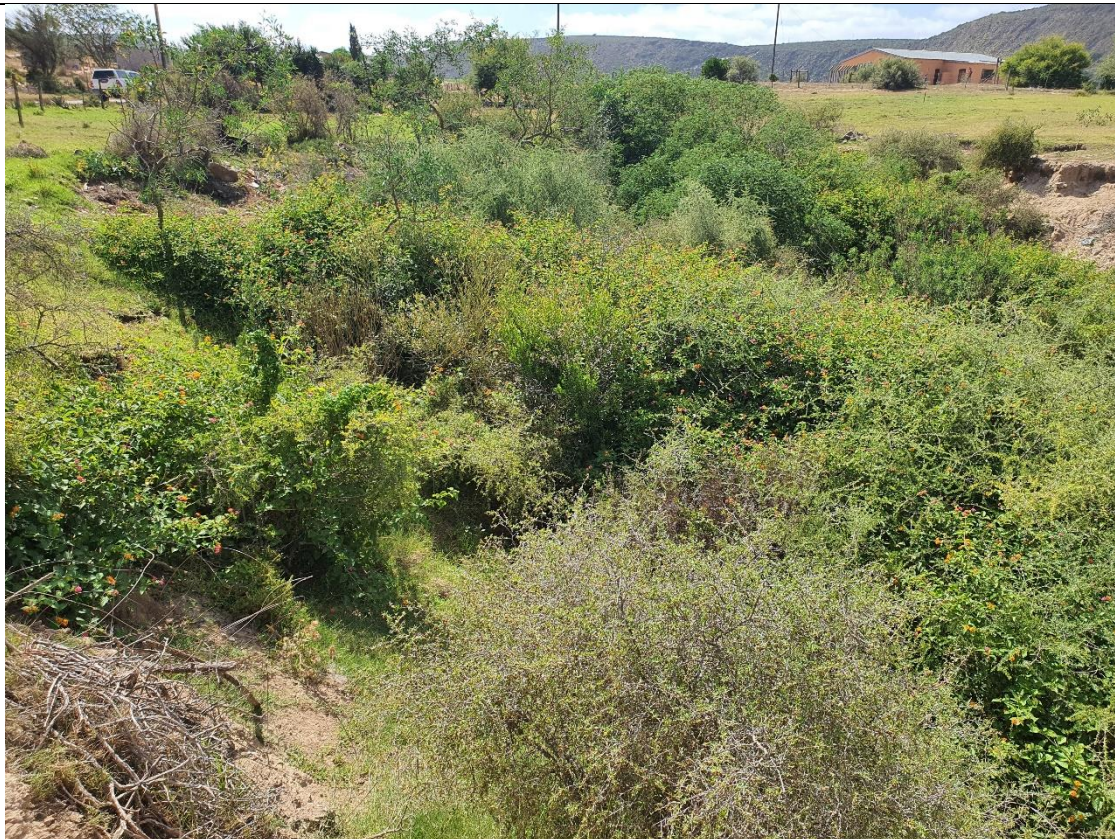
**Photos 1, 2 & 3:** These images were taken of the trench excavated on the site. Remnant pieces of waste as well as the regrowth of trees and other vegetation can be seen inside the trench.

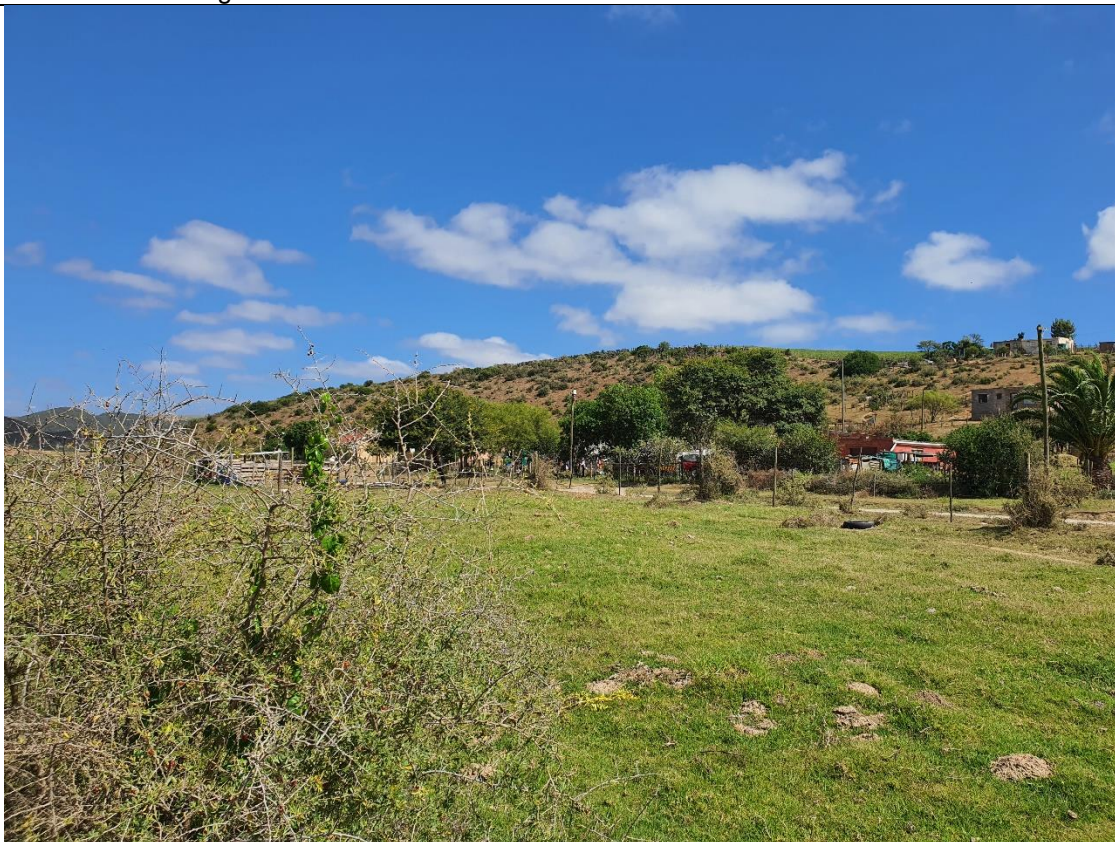
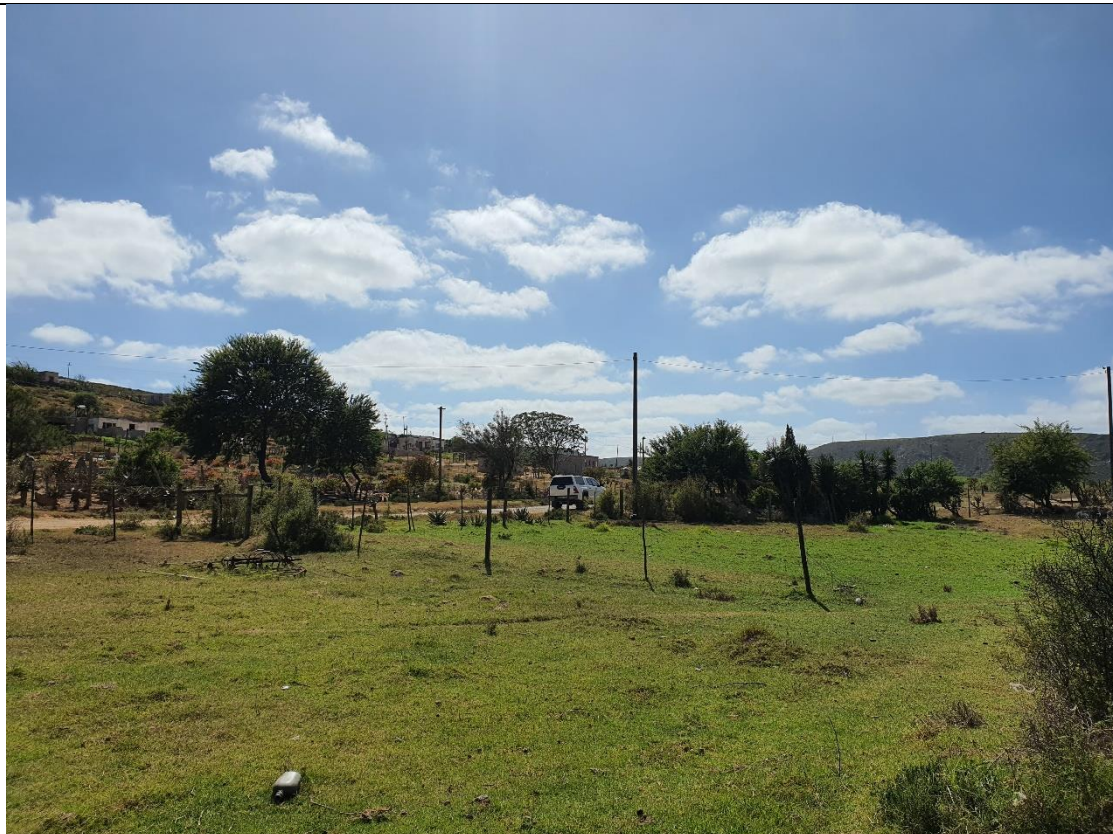
**Photos 4 & 5:** This image is taken of the internal road and the local houses that lie just north of the historical waste trench that was excavated on the site. The disturbed condition of the vegetation surrounding the trench can be seen in this image. It can also be clearly observed that the site is dominated by grass and scattered trees.

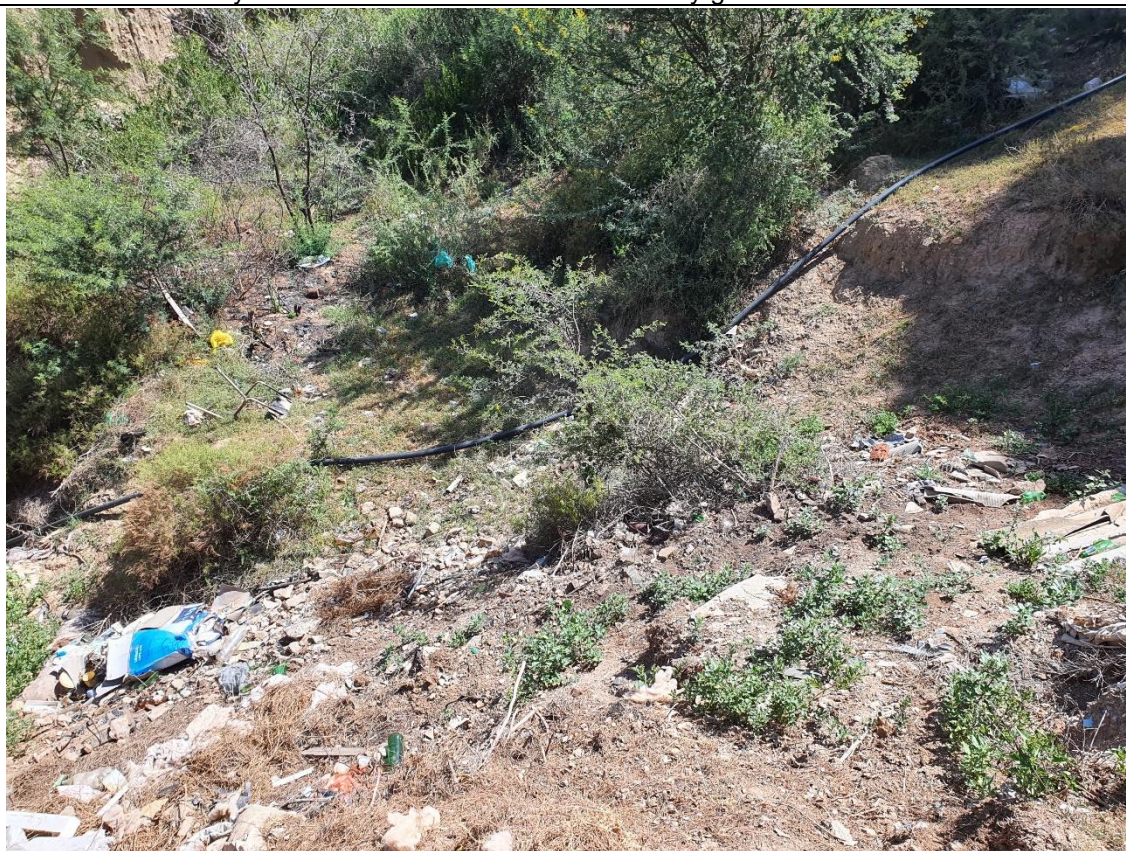
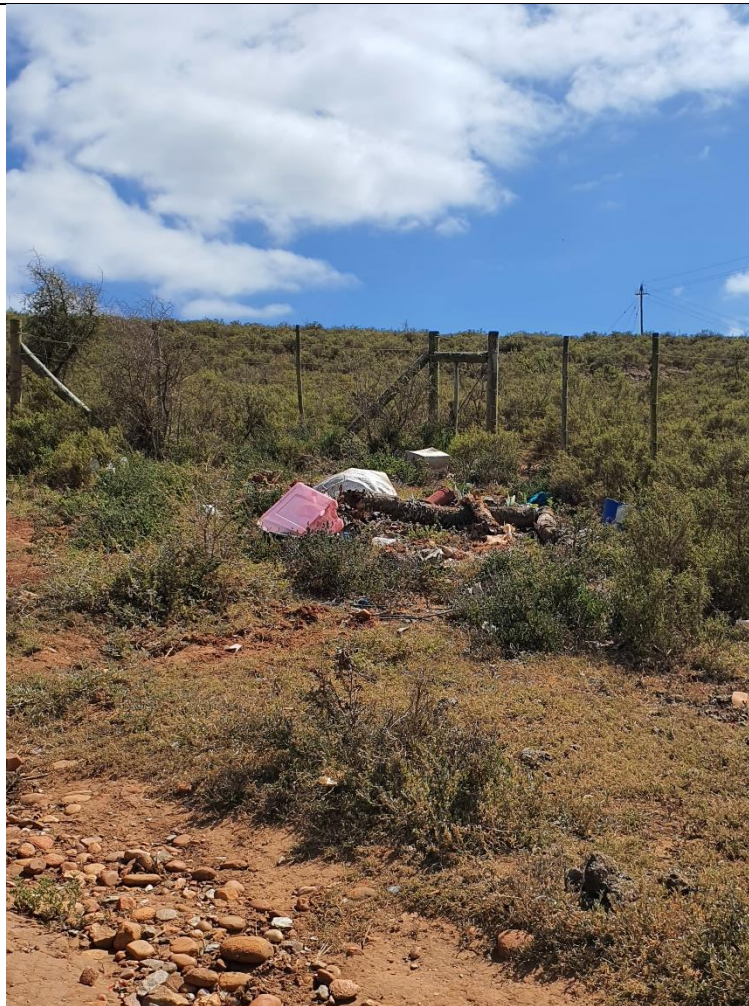
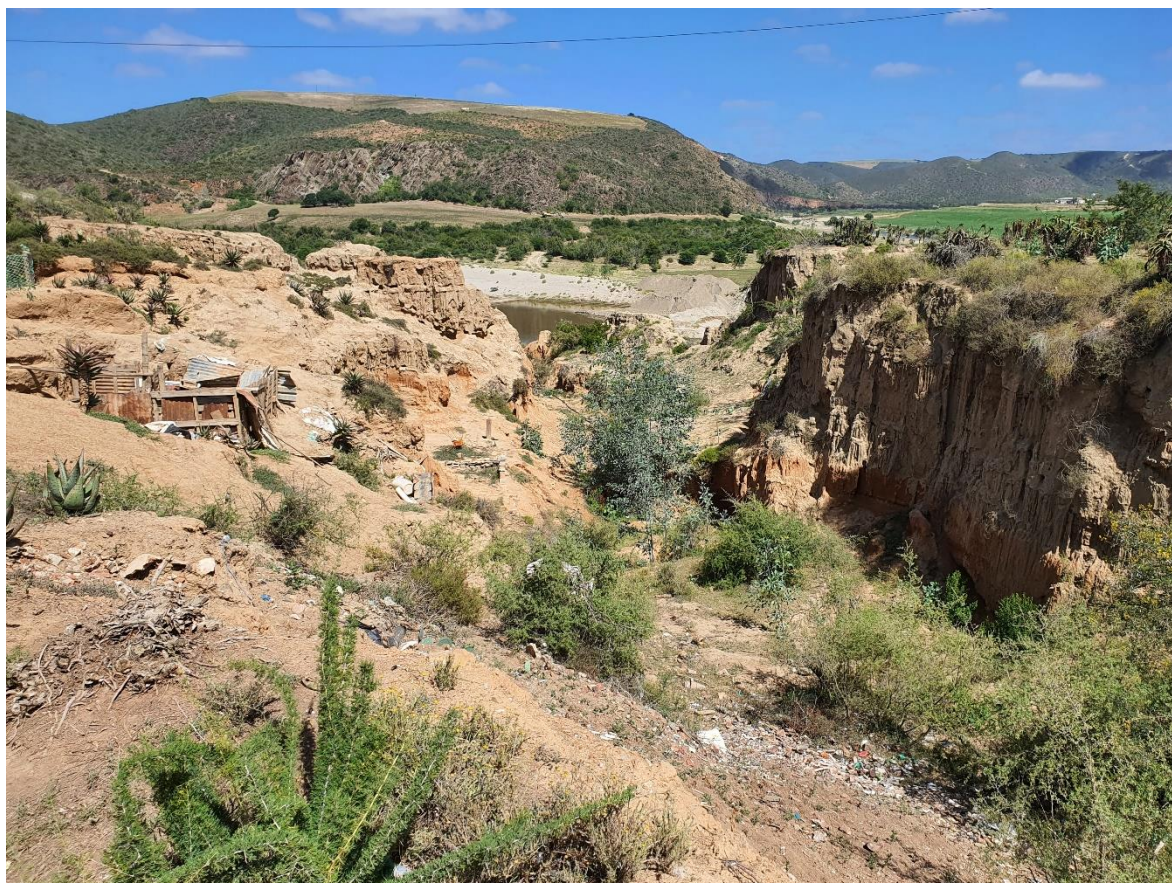
**Photos 6, 7 & 8:** Several other images were taken of the greater Buisplaas area, i.e., outside of the borders of the WDF considered for surrender in this application, in order to identify and capture other areas of scattered waste surrounding the town.
