# Aquatic Biodiversity Impact Assessment

## Proposed Carpe Diem Solar Photovoltaic Plant, Merafong City, Gauteng Province

Legacy Environmental Management Consulting

June 2025

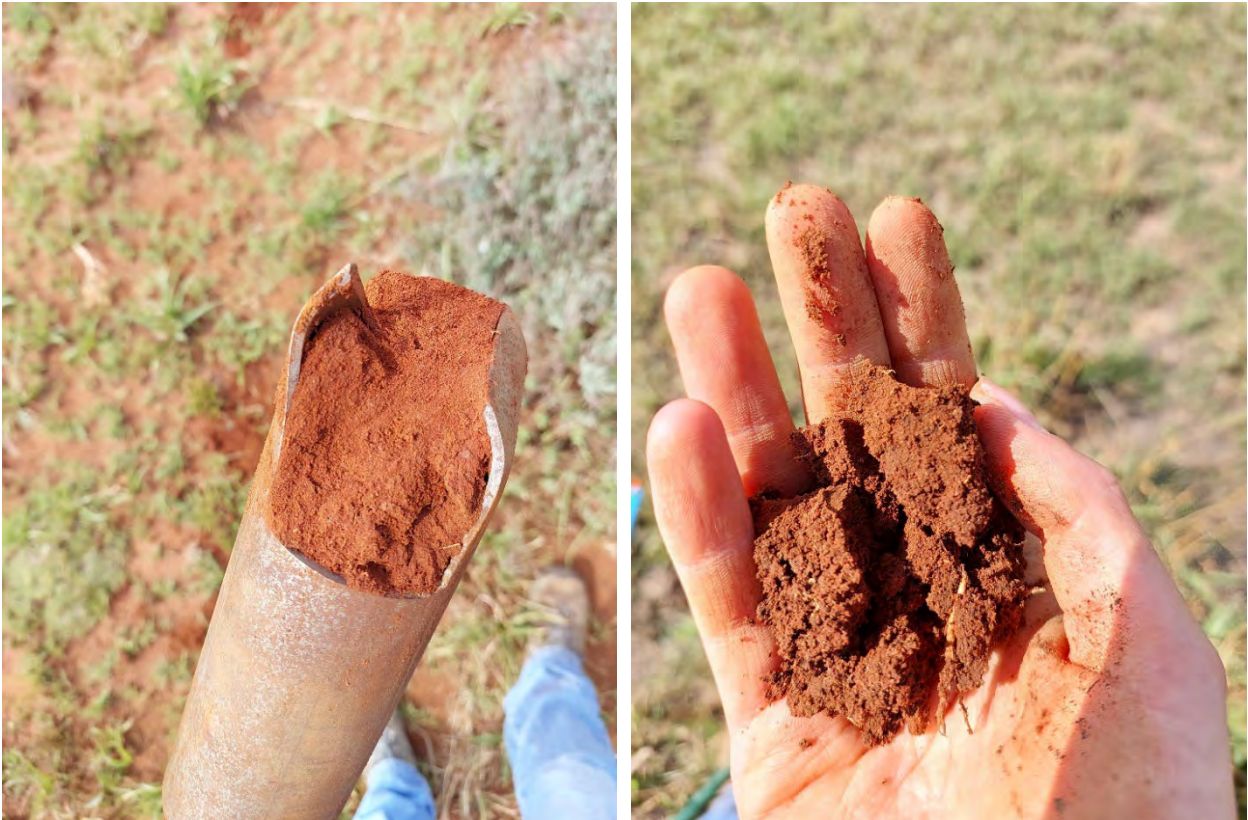
**Figure 5-3: Soil samples from Portion 5 of Farm Varkenlaagte No. 119 indicating an absence of hydromorphic soil indicators.**

the proposed site (**Figure 5-7 & Figure 5-8**). However, no wetland or riparian indicators were observed to be present within these areas which were assessed during the site visits (**Figure 5-3**).

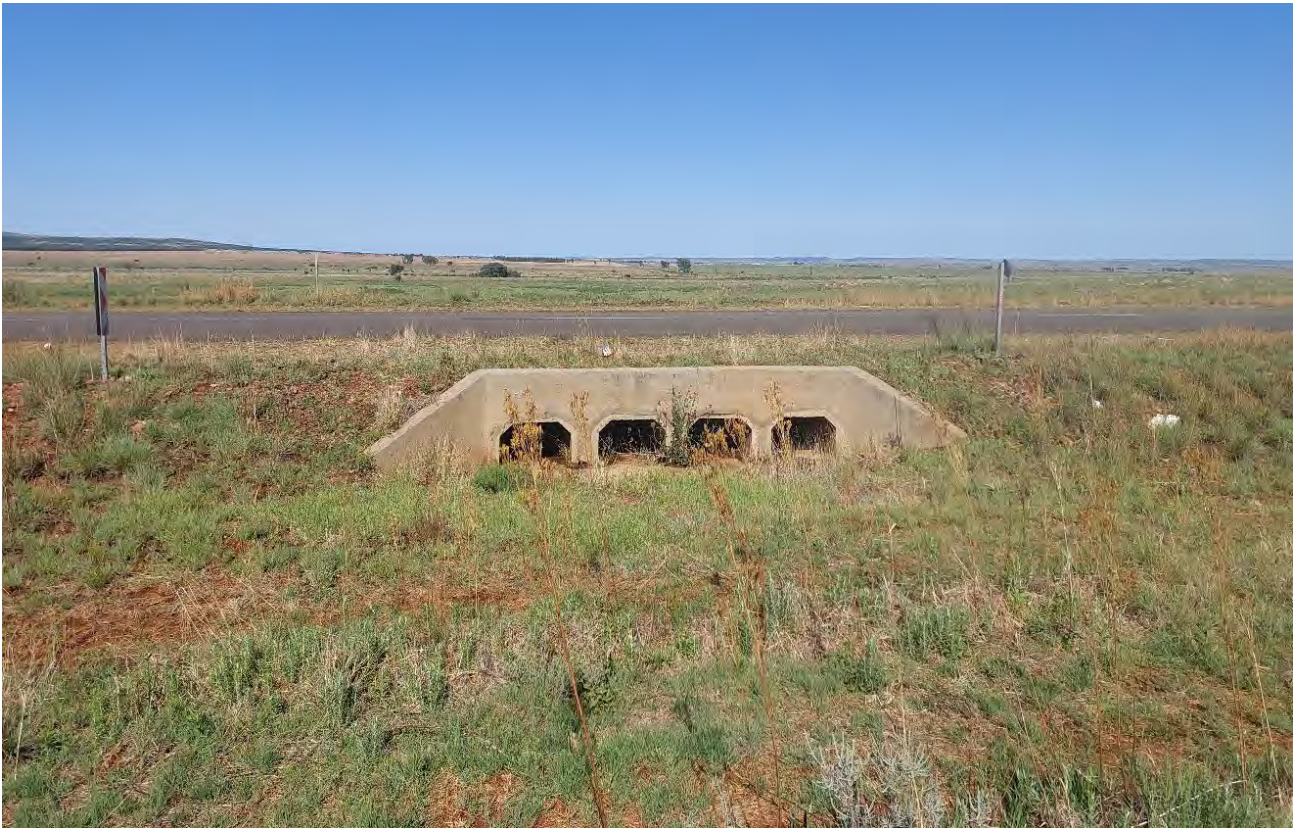
**Figure 5-7: Culvert located along the western border of Portion 5 of Farm Varkenlaagte No. 119.**

The site slopes from approximately 1598 m.a.s.l in the southeast corner to 1527 m.a.s.l in the northwest portion. The site was noted to be disturbed by agricultural activities including livestock grazing, particularly in the central and northern portions of the site. Several livestock feeding and watering troughs are located within and adjacent to the proposed site (**Figure 5-5**). Located in the north-western corner of the proposed site is an area which has previously been excavated (**Figure 5-6**). A concrete culvert is located along the road bordering the west of the proposed site, which likely receives stormwater from the road and runoff from rill erosion occurring in the northwest of

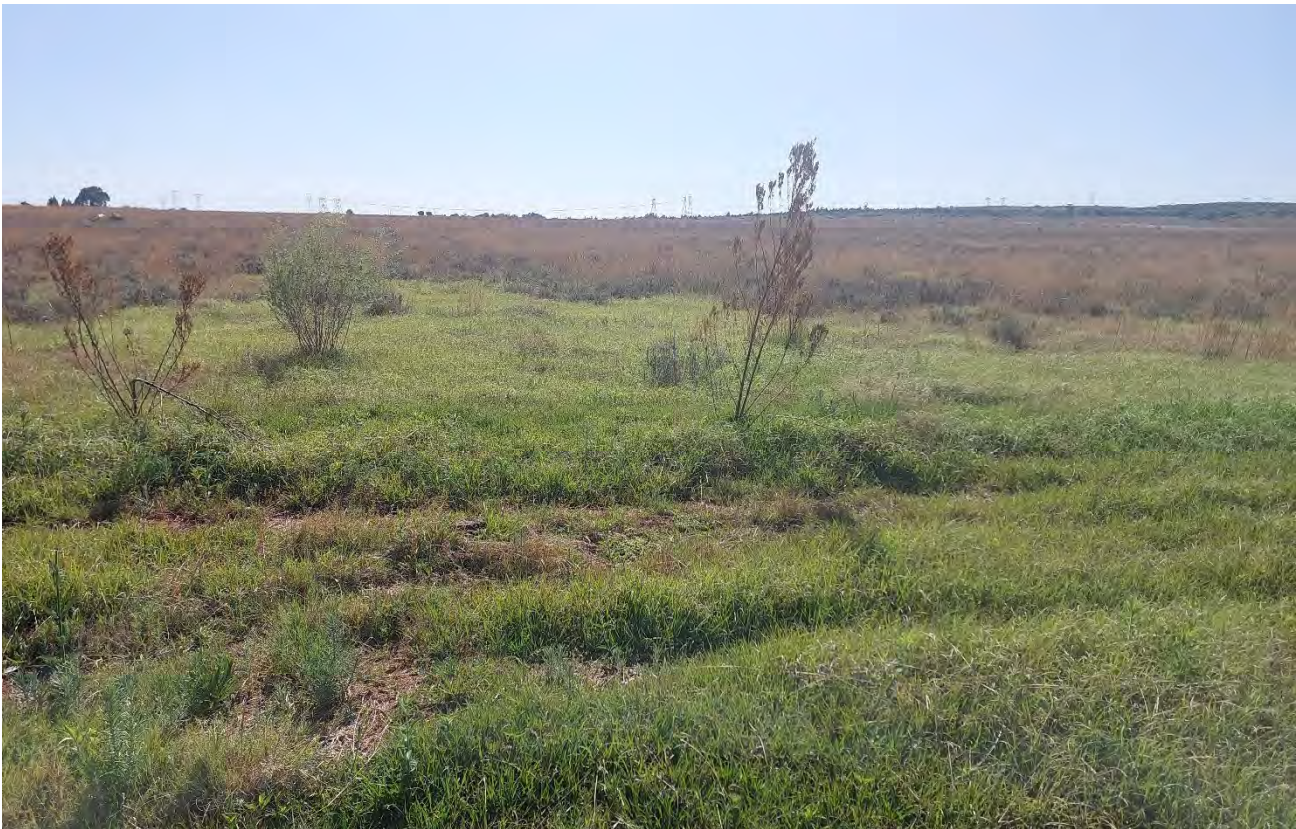
**Figure 5-8: Upstream of the culvert located along the western border of Portion 5 of Farm Varkenlaagte No. 119.**

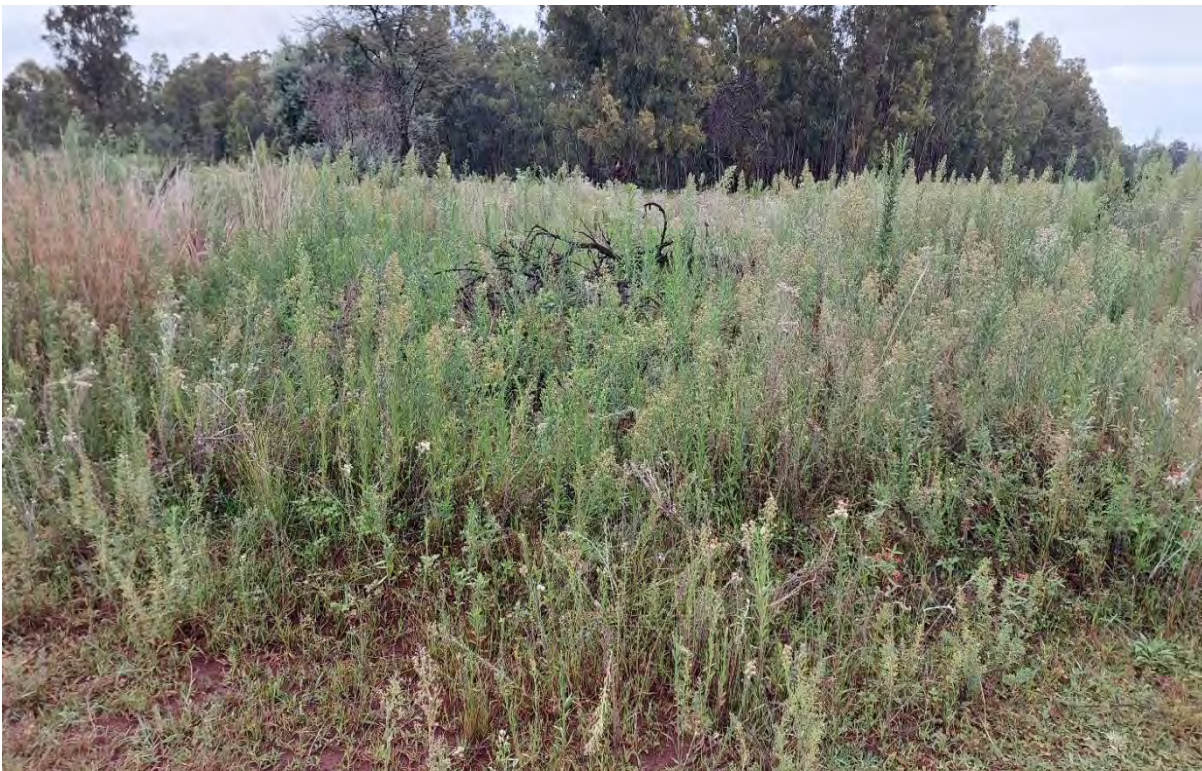
**Figure 5-12: UVBW located in the north of Portion 27 of Farm Doornfontein No. 118.**

- The hydrology of the UVBW has been influenced by the dirt track through the centre of the wetland area, and the *Eucalyptus* plantation located in the southern portion of the wetland area. The dirt track has concentrated and diverted flow in certain areas, while the *Eucalyptus* plantation has removed all the natural vegetation within the wetland. The replacement of natural vegetation with *Eucalyptus spp.* has caused reduced surface roughness and reduced infiltration rates. This results in increased runoff, erosion, and storm peak flows. Additionally, *Eucalyptus spp.* are associated with high rates of water use consequently causing a reduction in flow within wetland areas.

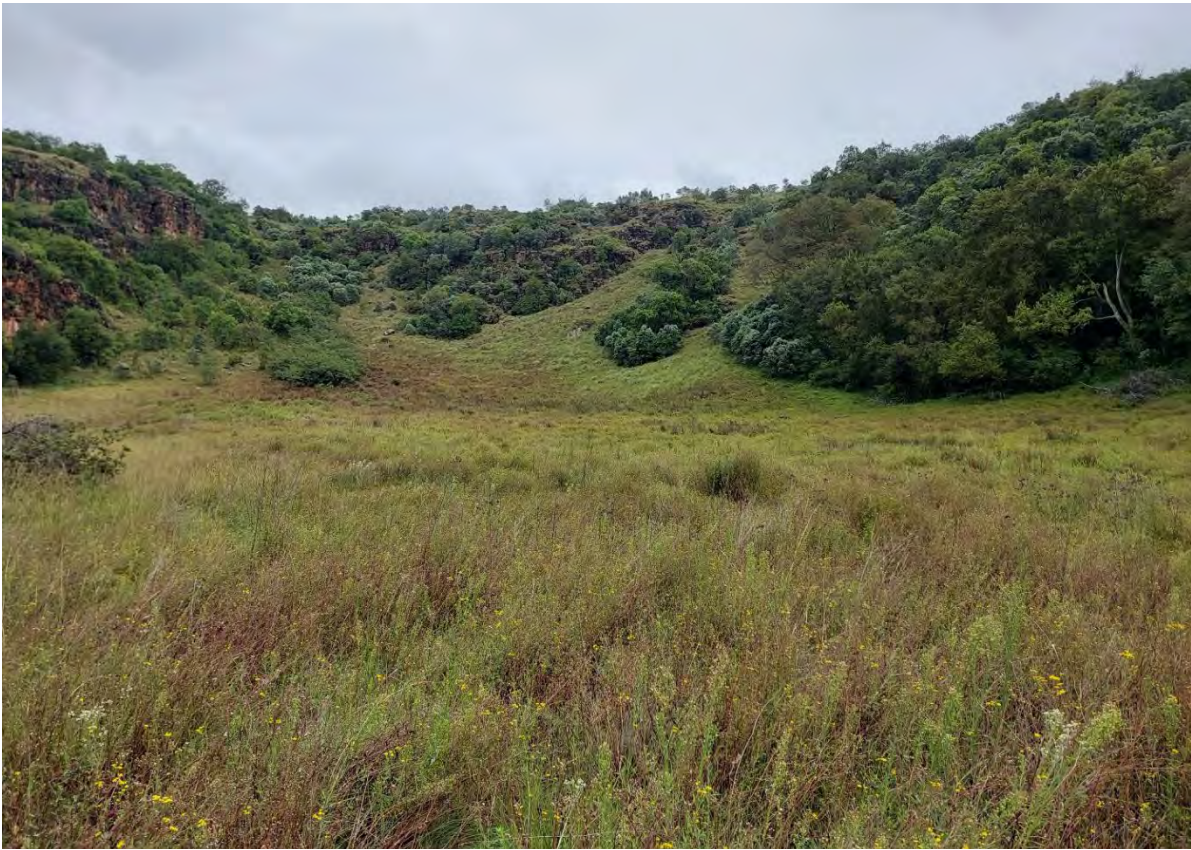
**Figure 5-13: Depression wetland located in the northeast of Portion 27 of Farm Doornfontein No. 118.**

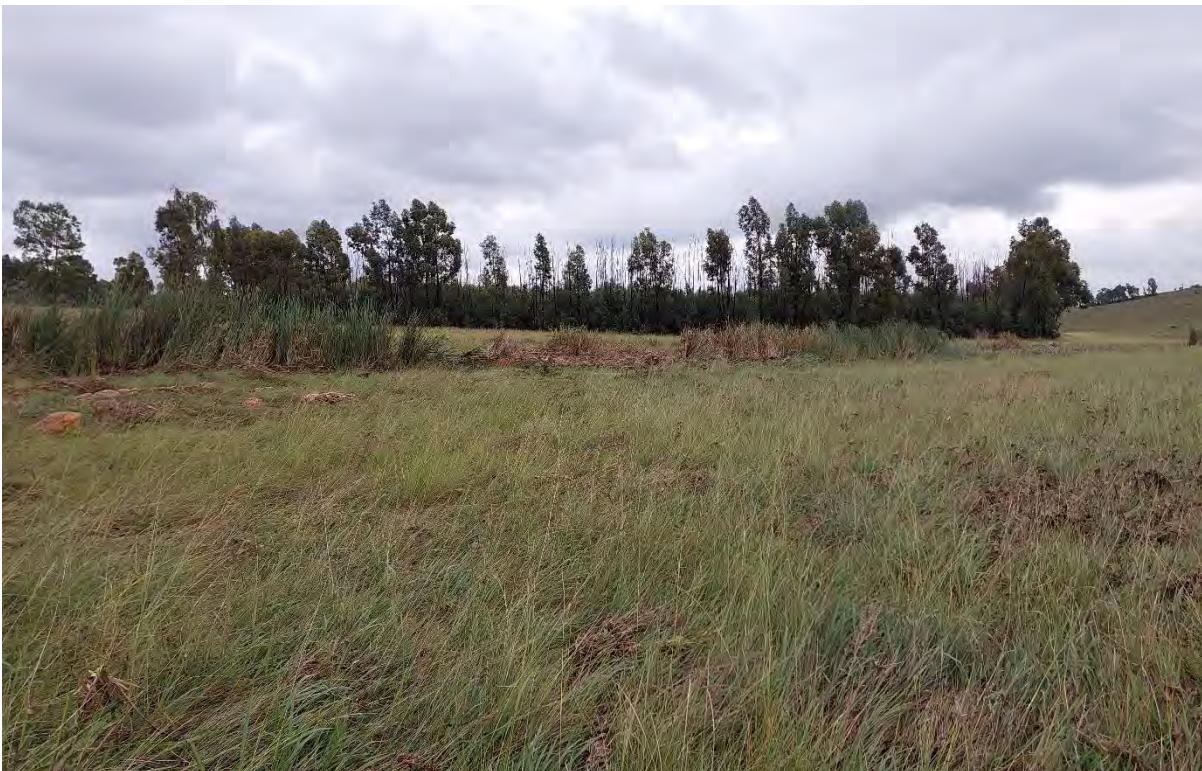
**Figure 5-14: CVBW located in the south of Portion 27 of Farm Doornfontein No. 118.**

- Vegetation in the CVBW consists primarily of indigenous wetland species *Typha capensis*, *Phragmites australis*, *Cyperus congestus*, and alien invasives such as *Eucalyptus* spp.
- Vegetation in the CVBW has been significantly impacted by the construction of the instream dam, historical agricultural activities such as ploughing, and existing agriculture (*Eucalyptus* plantations).
- No species of conservation concern were noted.

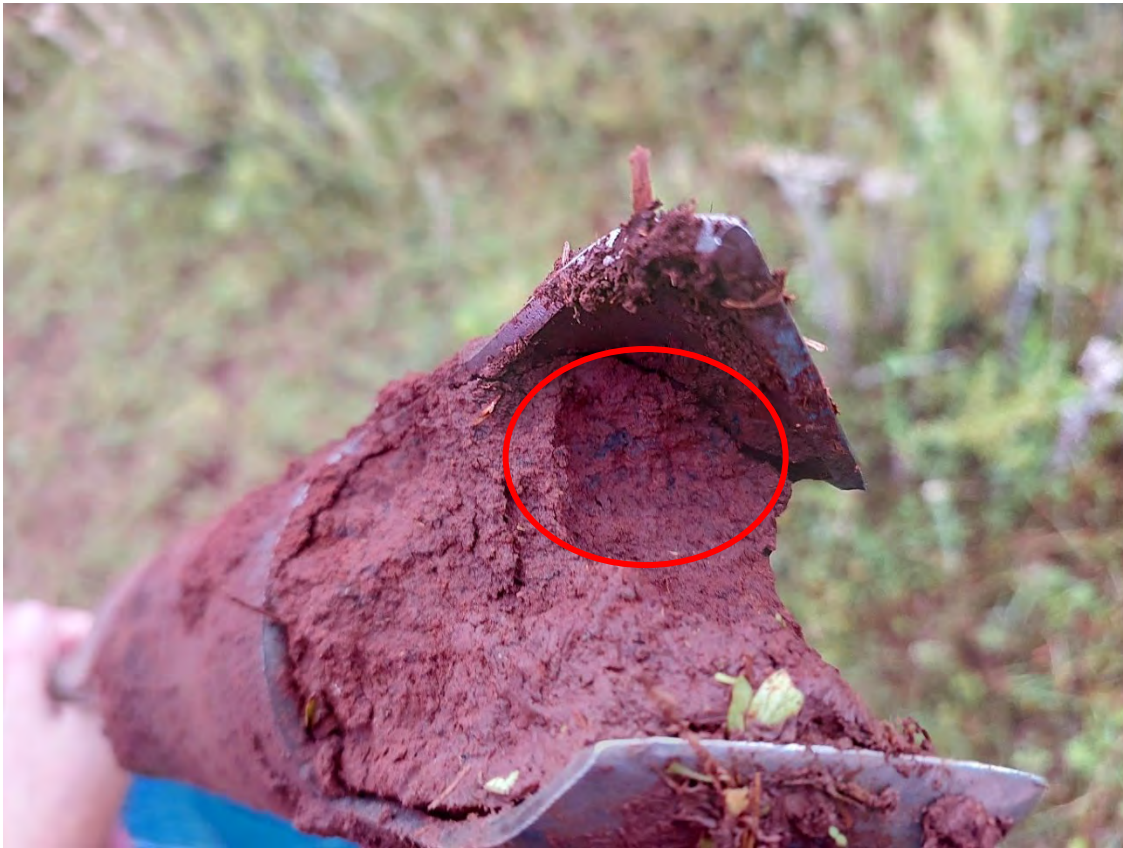
**Figure 5-15: Soil sample from UVBW indicating mottling.**

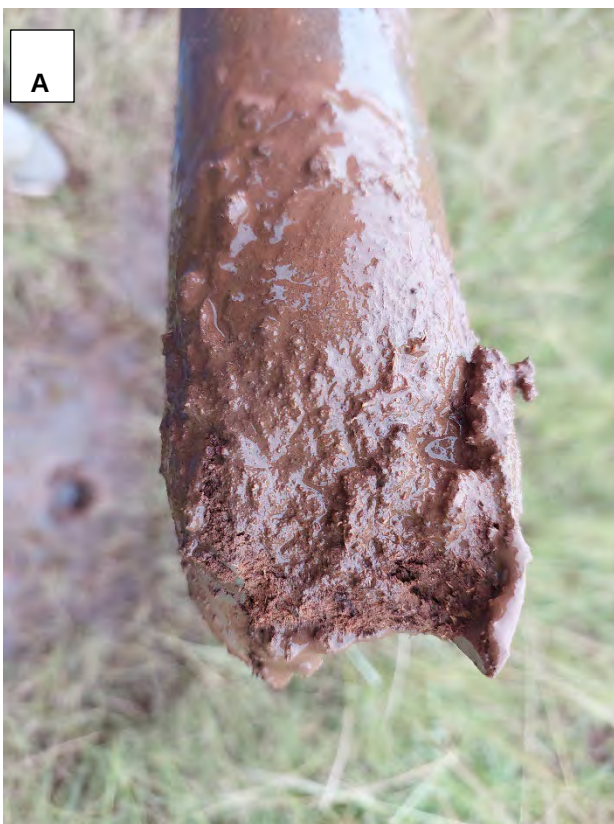
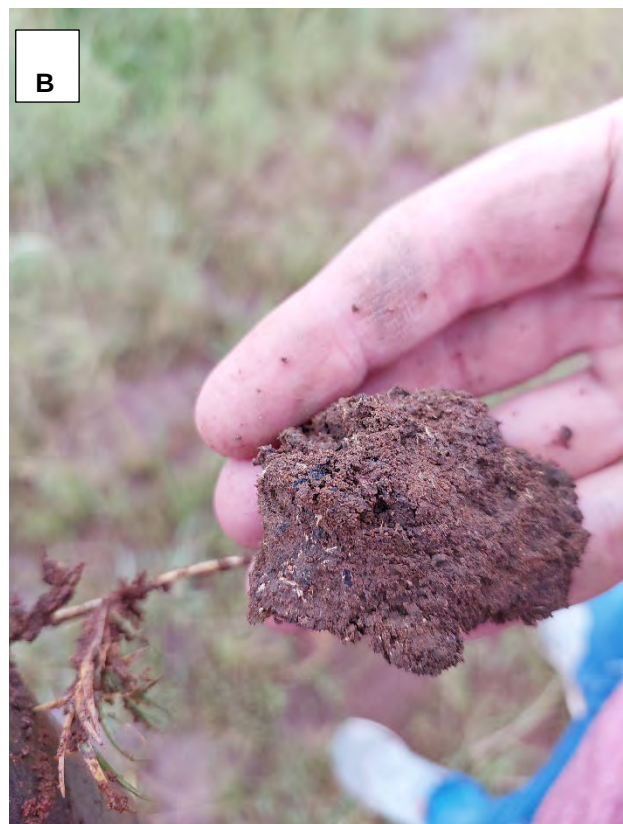
**Figure 5-16: Soil samples from the CVBW indicating A) saturated soil & B) hydromorphic soil features.**

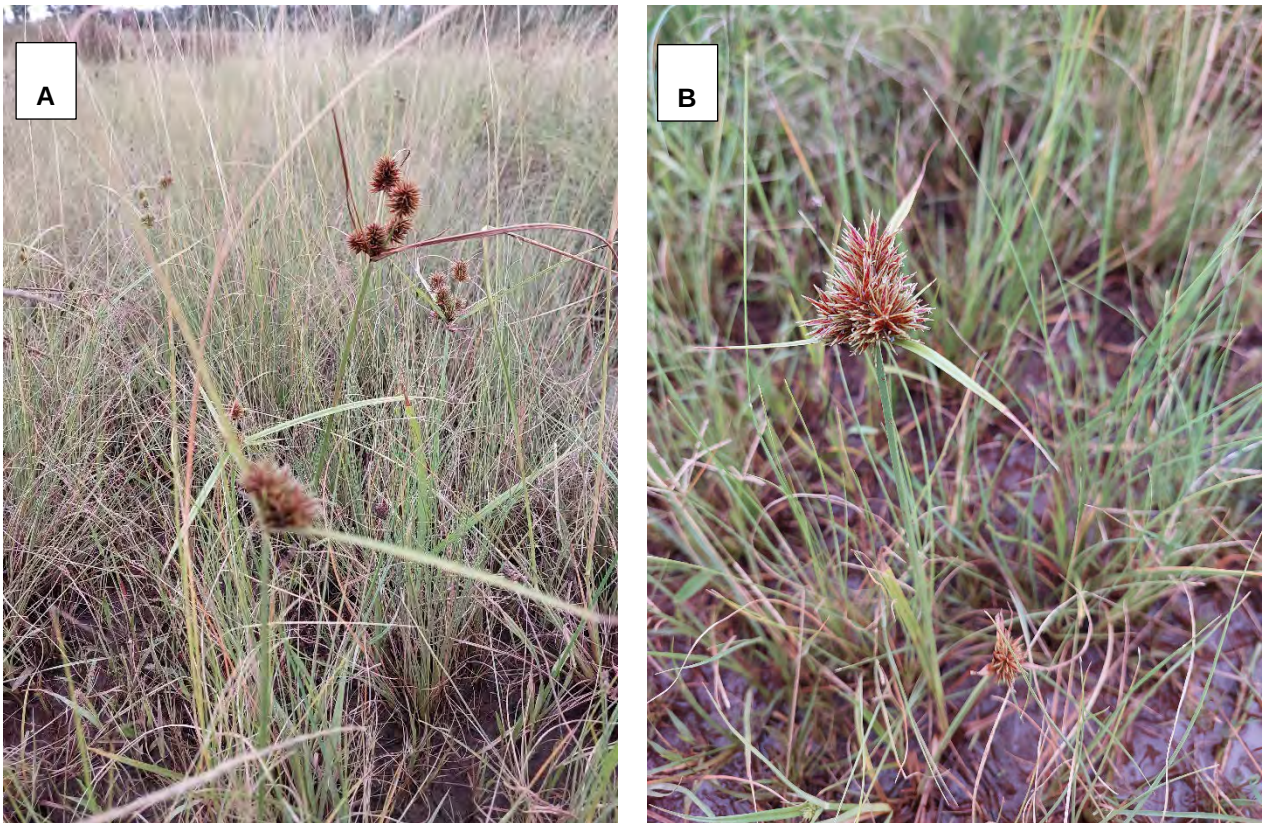
Figure 5-17: Wetland obligate species in CVBW includes *Cyperus congestus* (Purple Umbrella Sedge).

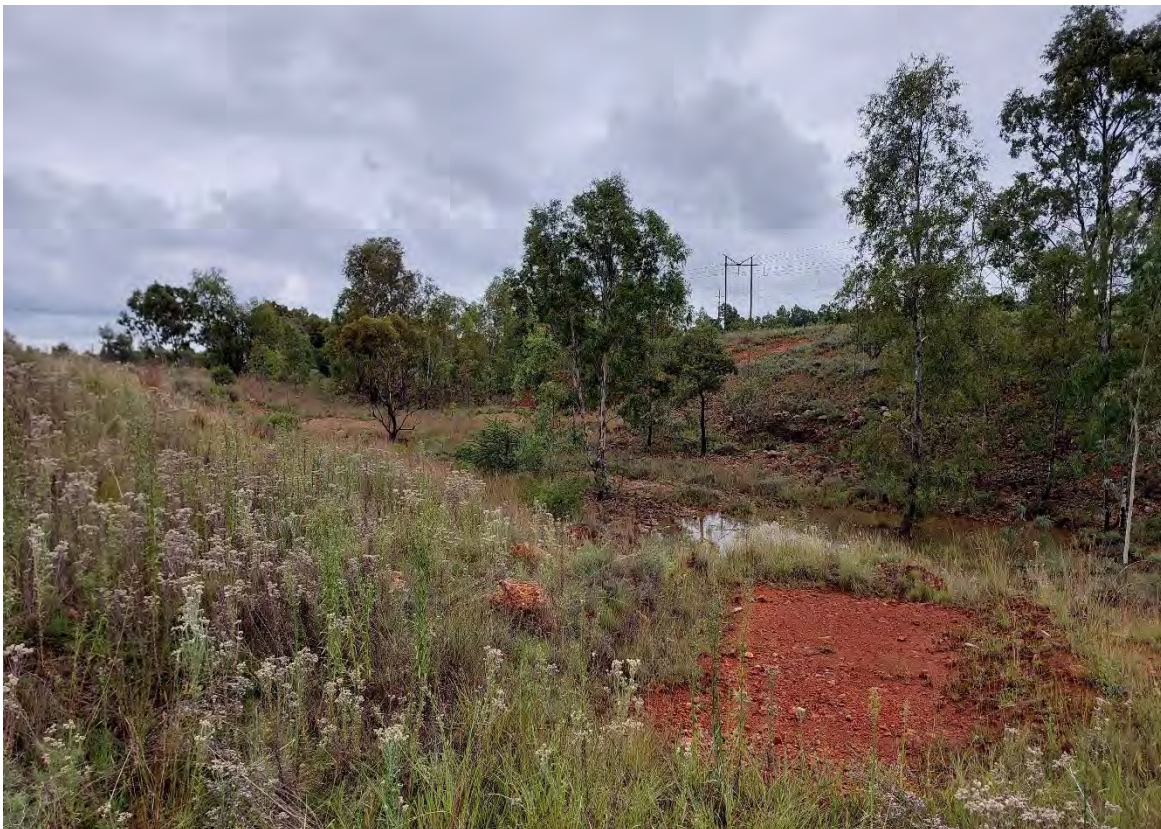
Figure 5-18: Excavations/diggings present along the eastern boundary of Portion 27 of Farm Doornfontein No. 118.

Several excavation/digging areas were noted along the eastern boundary of the site, along with a sinkhole located in the centre of the site (**Figure 5-18 & Figure 5-19**). The excavation areas were deemed to be artificial in nature, heavily disturbed and therefore lacking wetland functionality, and were not evaluated further as this assessment focused on natural watercourses which may be impacted by the proposed development. The sinkhole displayed no indicators typical of a wetland (i.e. lacked wetland vegetation and hydromorphic soil indicators).

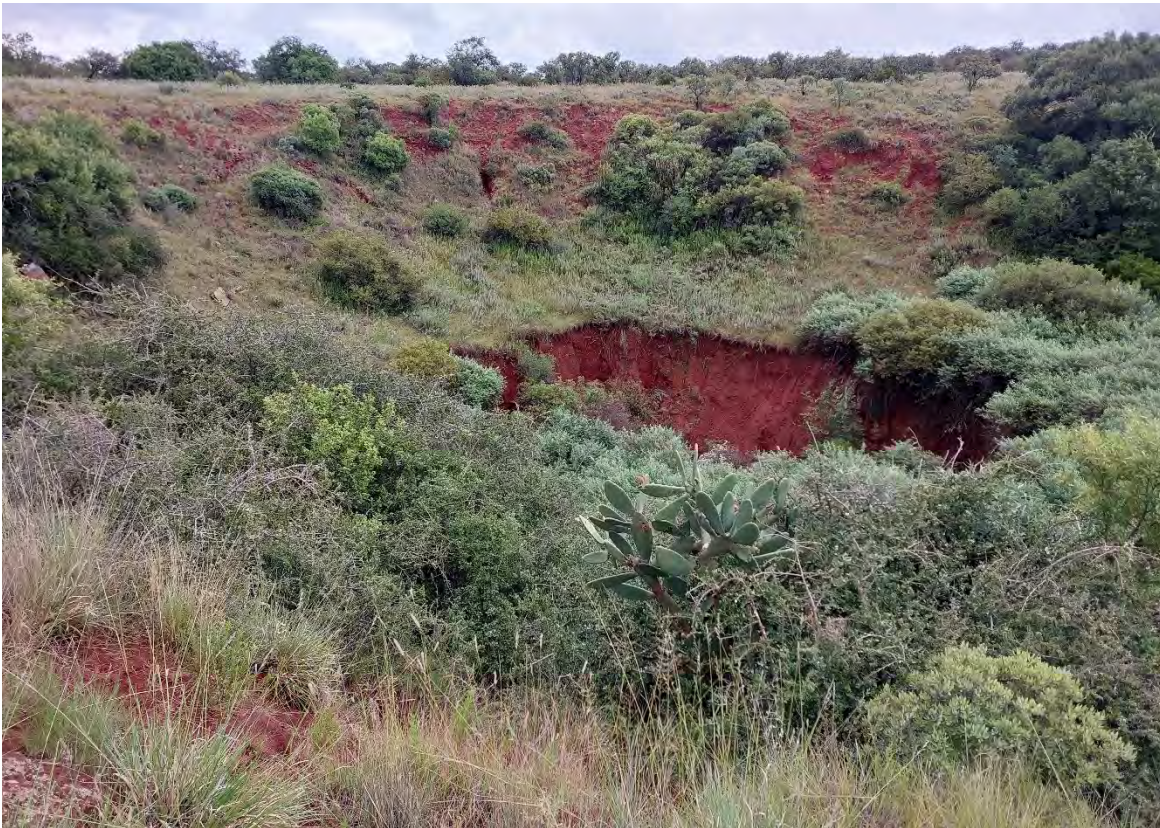
Figure 5-19: Sinkhole within Portion 27 of Farm Doornfontein No. 118.
